1. REPORT NUMBER		2. GOVT ACCESSION NO.		3. RECIPIENT'S CATALOG NUMBER	
4. TITLE (and Subtitle) Phase I Inspection Report Inghams Dam Mohawk River Basin, Herkimer and Fulton Counties, Inventory No. 183 NY				5. TYPE OF REPORT & PERIOD COVERED Phase I Inspection Report National Dam Safety Program

17. DISTRIBUTION National Dam Safety Program. Inghams Dam (Inventory Number NY 183). Mohawk River Basin, Herkimer and Fulton Counties, New York. Phase I Inspection Report.

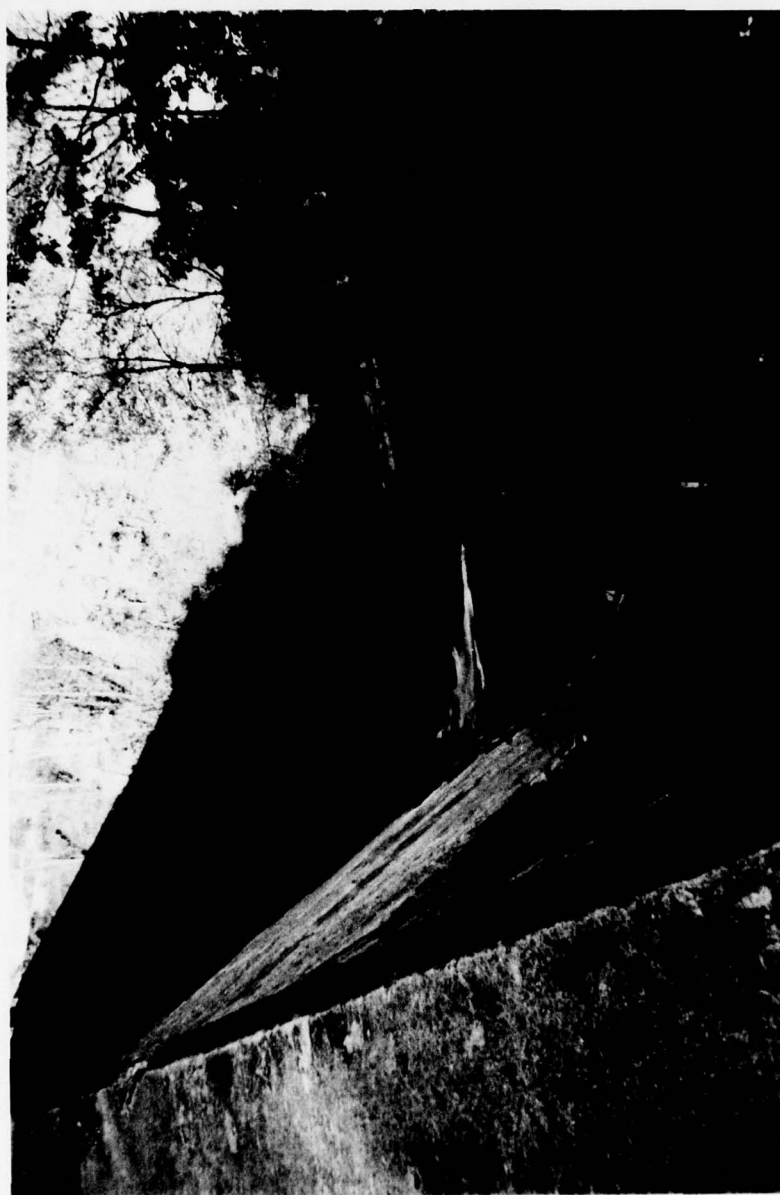
Photograph #3

Overview of Non-overflow Section  
from top of dam

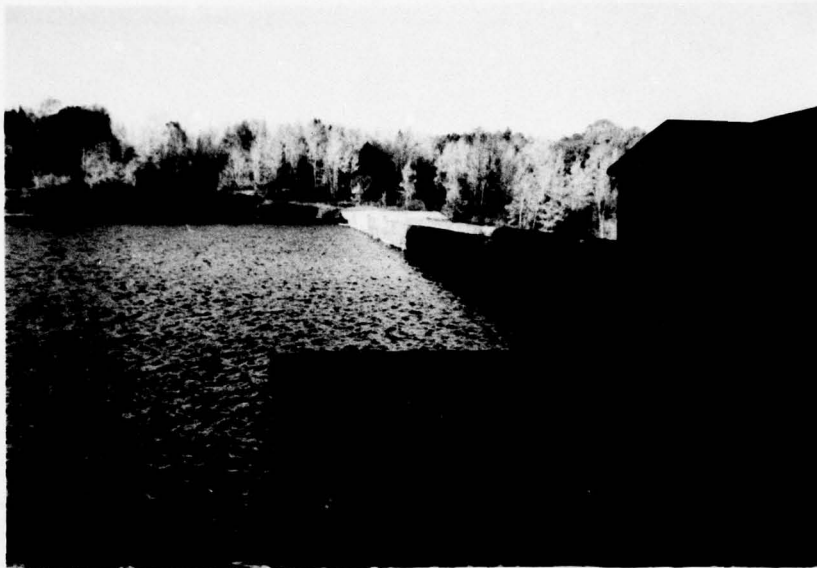
Photograph #12

The non-overflow section has not been rehabilitated since its original construction. There are no signs of horizontal or vertical misalignment and no indication of distress or cracking. No seepage was evident at any location. Some surface spalling of the concrete was evident on the downstream face with the maximum depth estimated to be 3 inches and the average depth of approximately 1 inch (see photographs #4, 5 & 6). Surface spalling (see photographs #8, 9 & 10) was also apparent on the parapet walls. No internal drainage system was provided. However, 6 borings were progressed in June 1970 to determine uplift pressures and these holes have remained open. No flow was observed from these holes. Boring logs for this work have been included in Appendix F "Stability Analysis". The intake structure for the penstock, located near the south end of the dam is in good condition. Some minor ice caused damage was apparent in the concrete walls of intake structure. (See photographs #8 & 12).

Upstream Face of Non-Overflow Section  
and Intake Structure

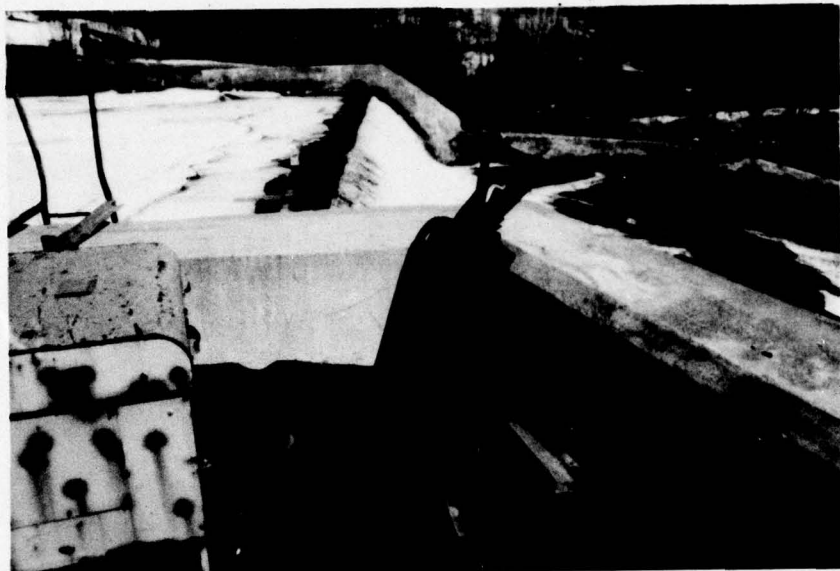
Photograph #20

Ogee Spillway without flashboards looking north  
Note bent bars salvaged after failure of flashboards

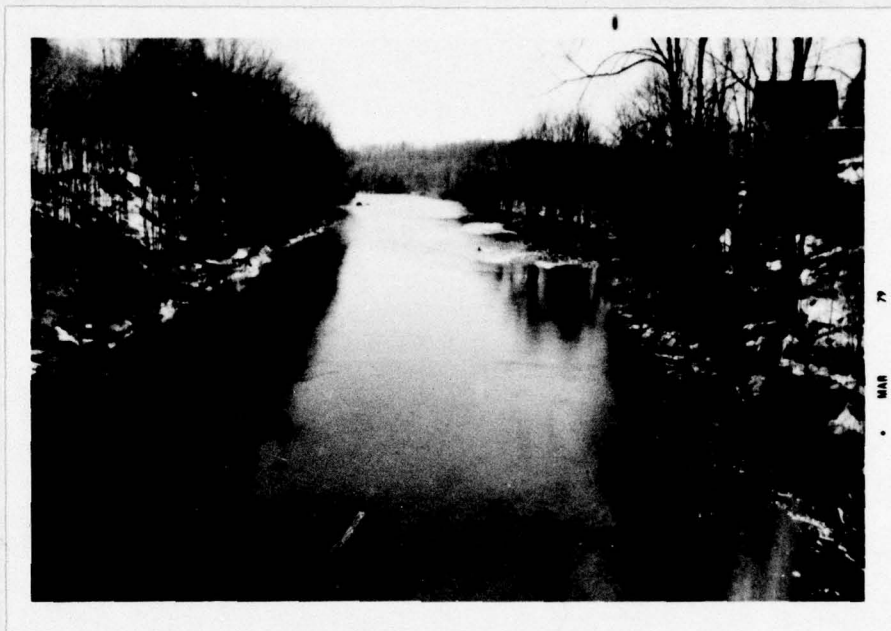
Photograph #22

The downstream channel is primarily bedrock formed and appears in good condition. (See photographs #19 & 22). A bridge located below the power house controls the flow of the channel. Some debris was observed in the downstream channel.

Downstream Channel  
as viewed from downstream bridge  
below power house

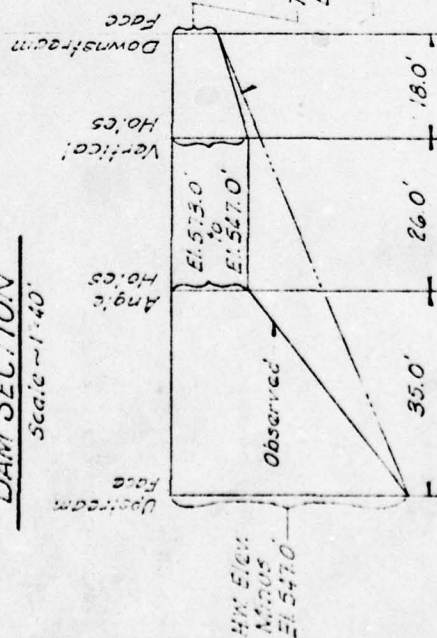
UPLIFT PRESSURE DIAGRAM-HEAD IN FEET

All cases assumed uplift as shown in Plate I Appendix F, which was the actual measured uplift conditions.
